9 ROXBURY ROAD SCARSDALE, NEW YORK

Tech Notes

NUMBER 19

Repairing Steel Casement Windows

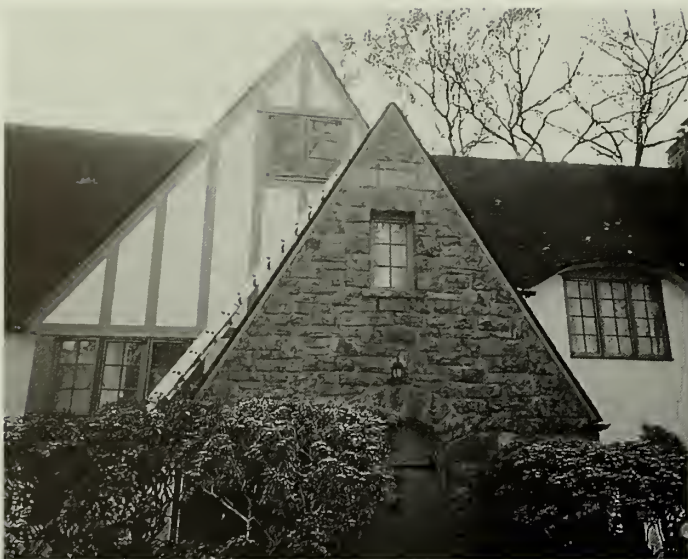
Figure 1. Steel casement windows were placed in various configurations throughout the house. Grouped windows open in opposite directions from each other, assuring that breezes can be captured, and a sash opened during rainy weather, regardless of the wind direction.

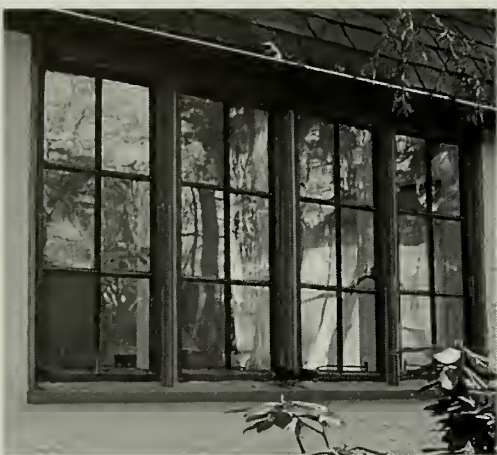
Figure 2. Each casement sash had six lights with projecting hinges that allowed the unit to open outward. Note the variation among glass panes as seen in the reflections. Caused by small differences in the positioning of panes within the sash and minor imperfections in the glass itself, this appearance is an important characteristic of historic windows.

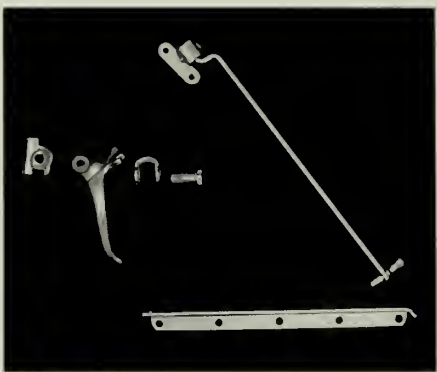
Figure 3. The window hardware at 9 Roxbury Road included a two-part "lift and stay" operator (right) and a common locking handle (disassembled at left). The hinged portion of the lift and stay (upper right) is attached to the sash while the perforated length is connected to the frame. To open the window, the pin is lifted from the hole on the far right, the sash is pushed open and the pin reset in one of the adjacent holes.
